## AZ1L Direct-View LCD Television Chassis

### Circuit Description and Troubleshooting Guide

MODELS:     KDL22EX308  
               KDL32EX308

**Course : CTV-68**

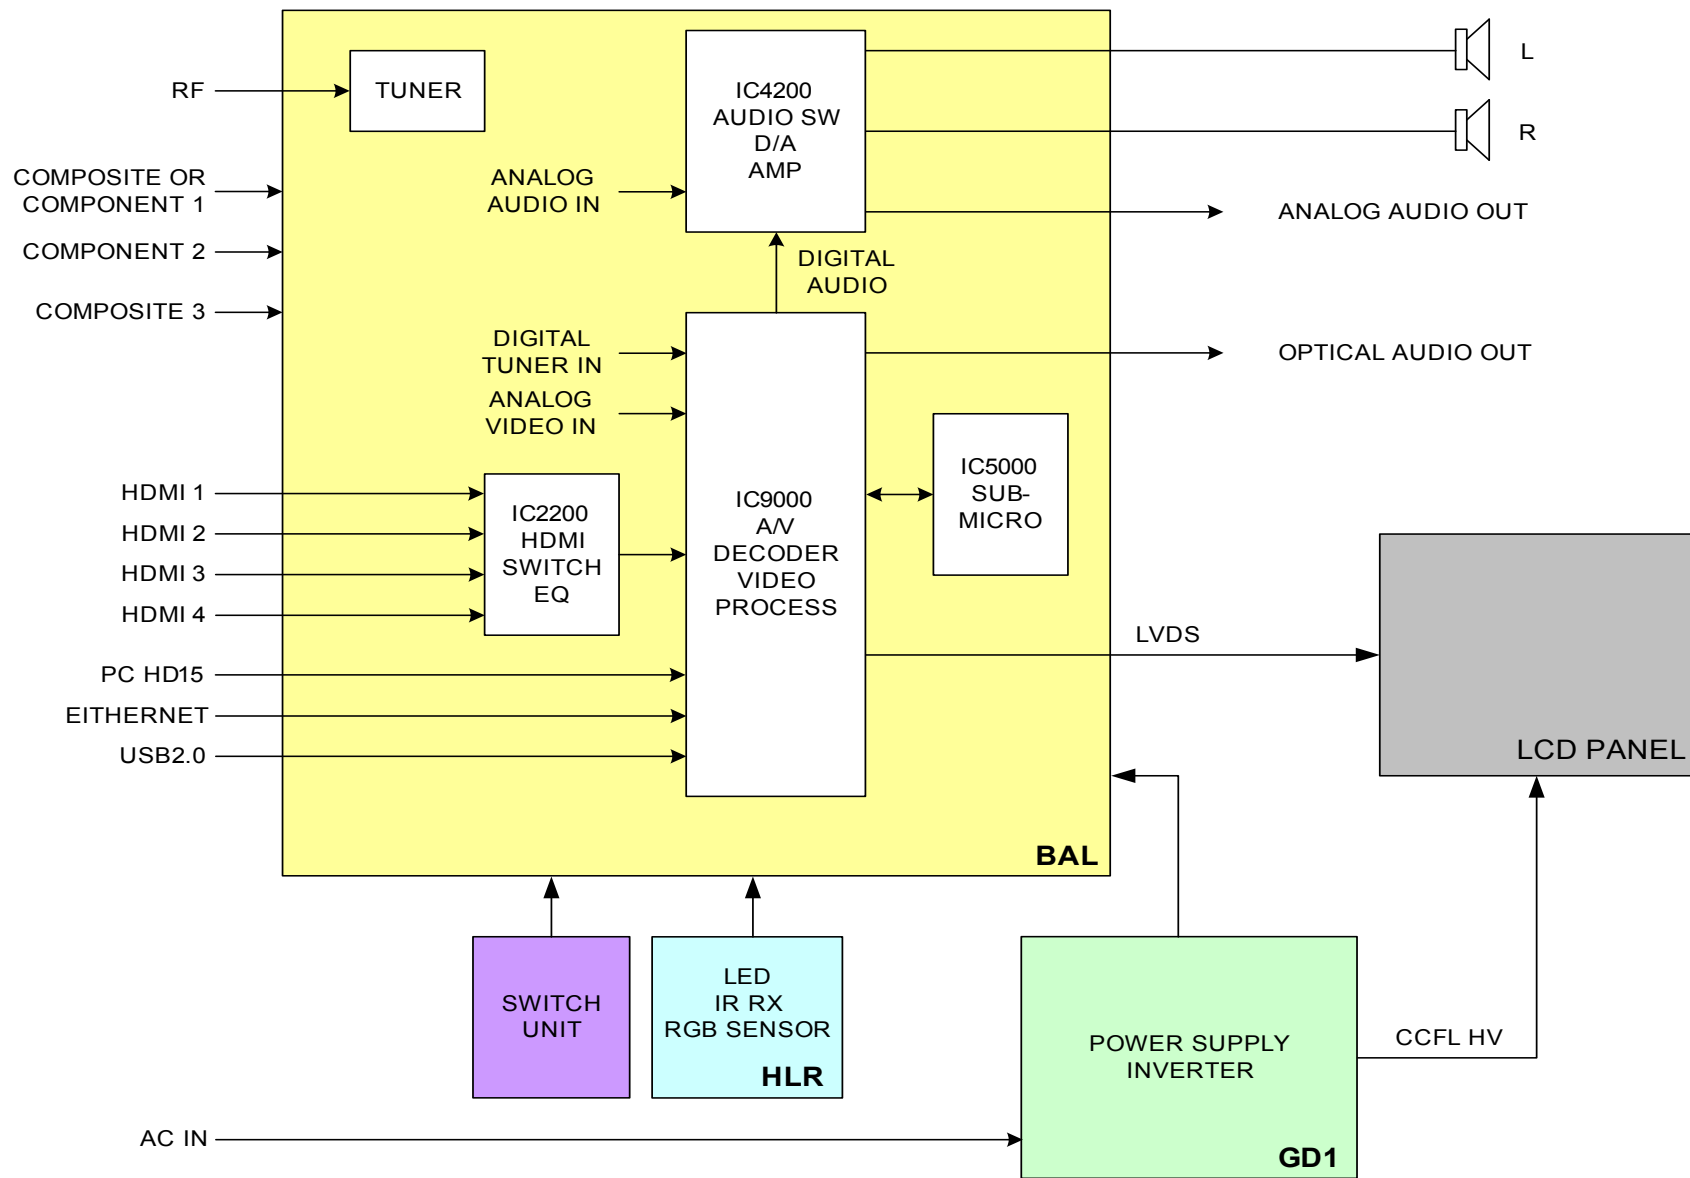
FIGURE 2-1  
22EX308 OVERALL BLOCK DIAGRAM

Figure 2-1 illustrates an overall block diagram of the KDL22EX308. Figure 2-2 illustrates an overall block diagram for the KDL32EX308. Both chassis designs share most of the same circuits with the power supply and high voltage circuits to supply the lamp voltages being the significant difference. Below is a description of the components and their function for the KDL22EX308.

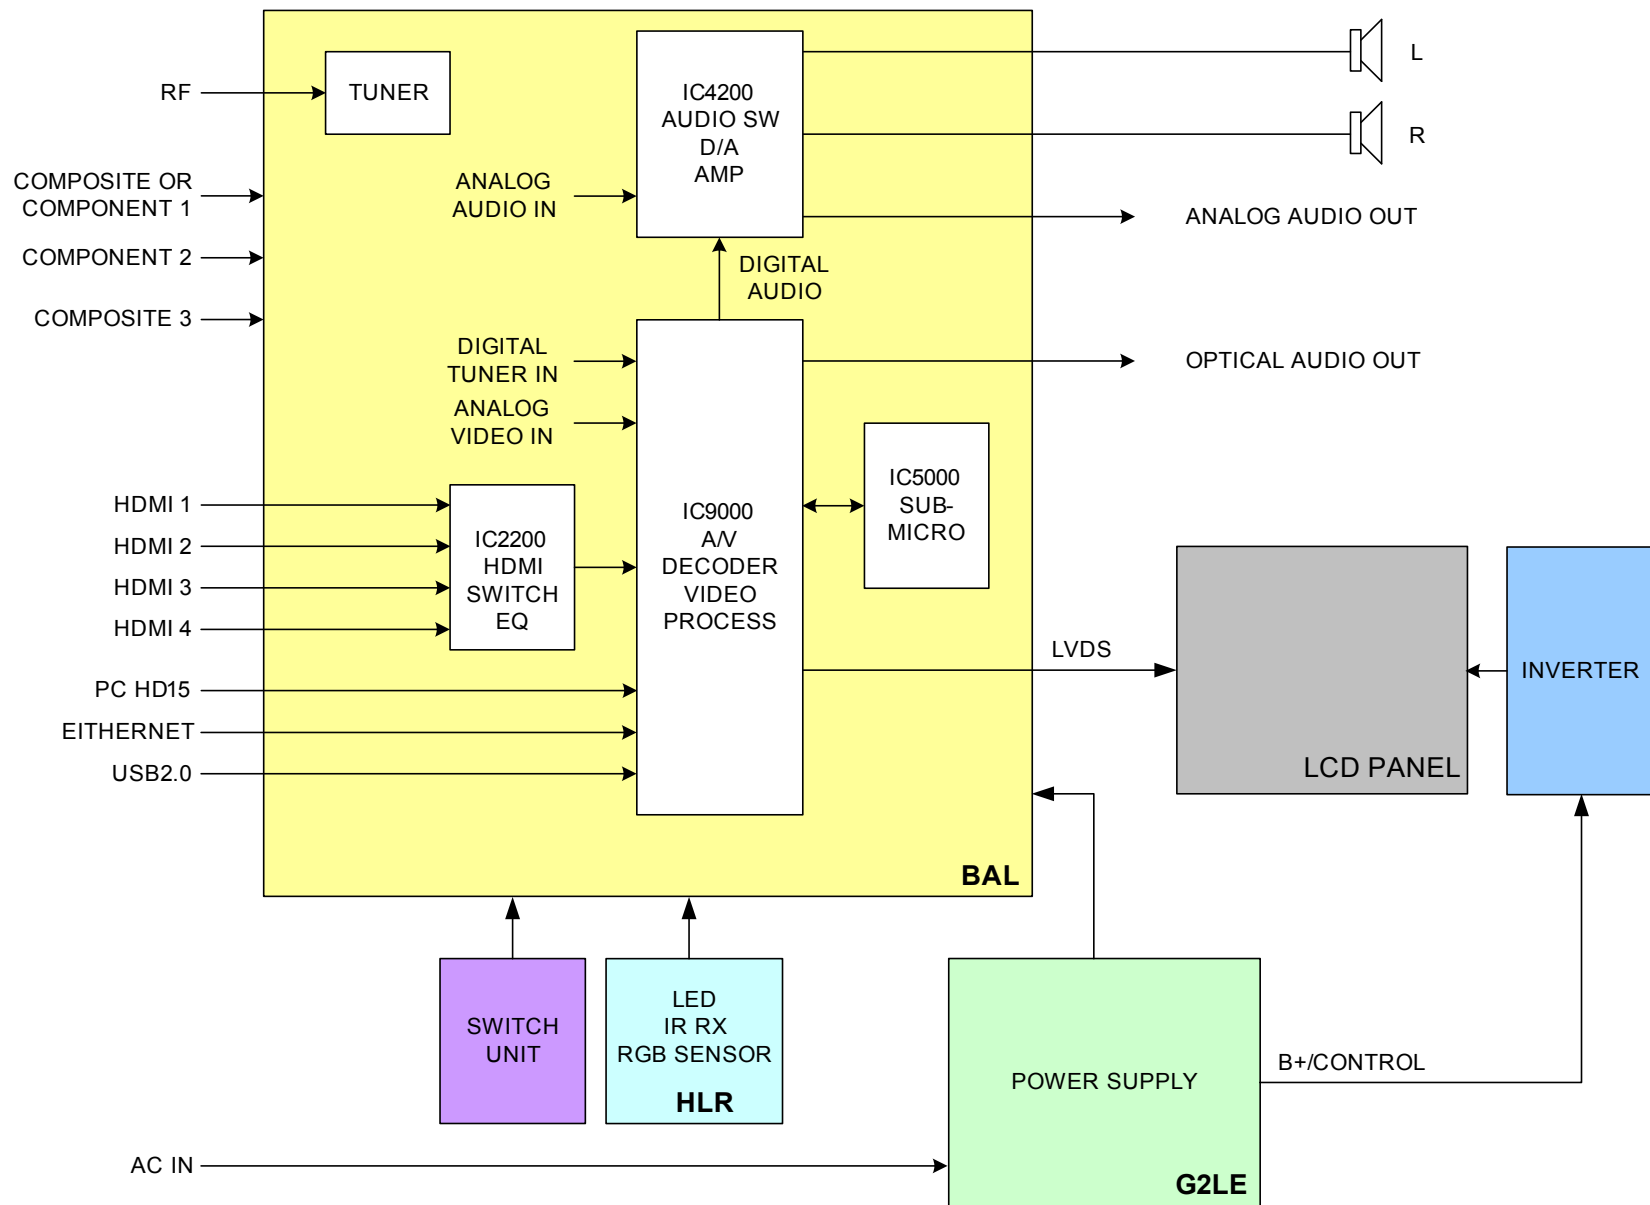
FIGURE 2-2  
32EX308 OVERALL BLOCK DIAGRAM

Referring to Figure 2-2 the KDL32EX308 utilizes the G2LE power supply board. All of the other circuits are the same as the KDL22EX308 except for the following circuits:

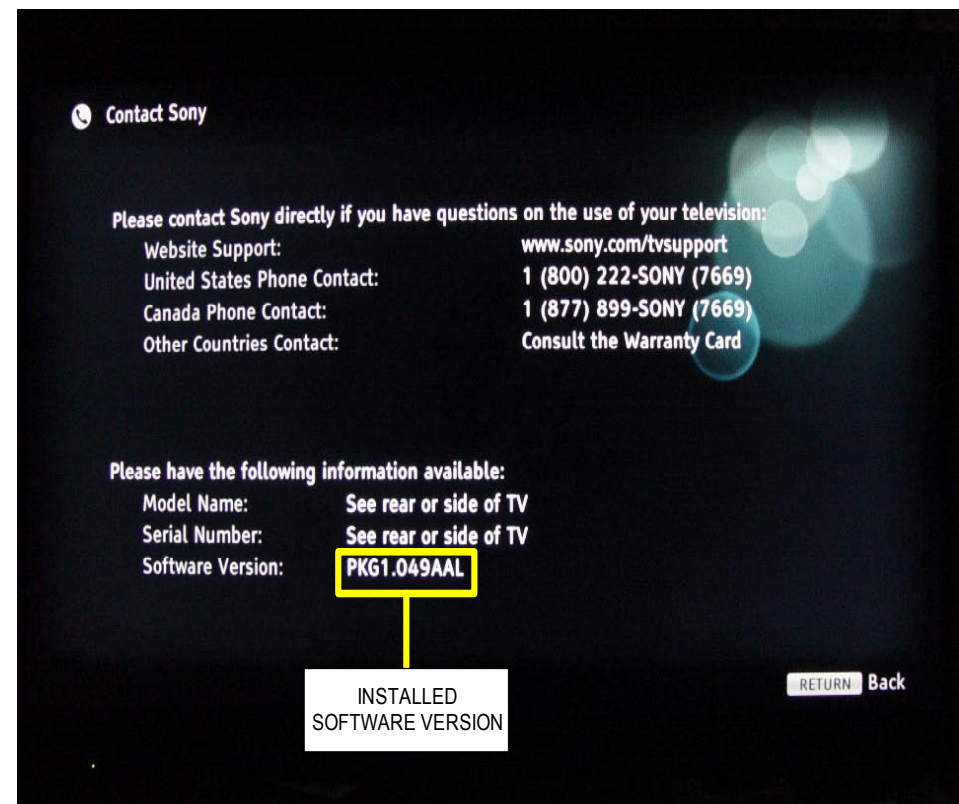
FIGURE 3-1  
CHECKING THE SOFTWARE VERSION

The easiest way to check the version of software is to use the customer menu. Engage the XMB graphics by pressing "HOME" on the remote commander. Scroll left on the graphics icons until the end is reached. Scroll up and select the "Product Support" icon. Select "Contact Sony". The information illustrated in Figure 3-1 will appear. Compare the package version listed on the screen with the version available on line. Install the software if the on line version is a higher numbered version.

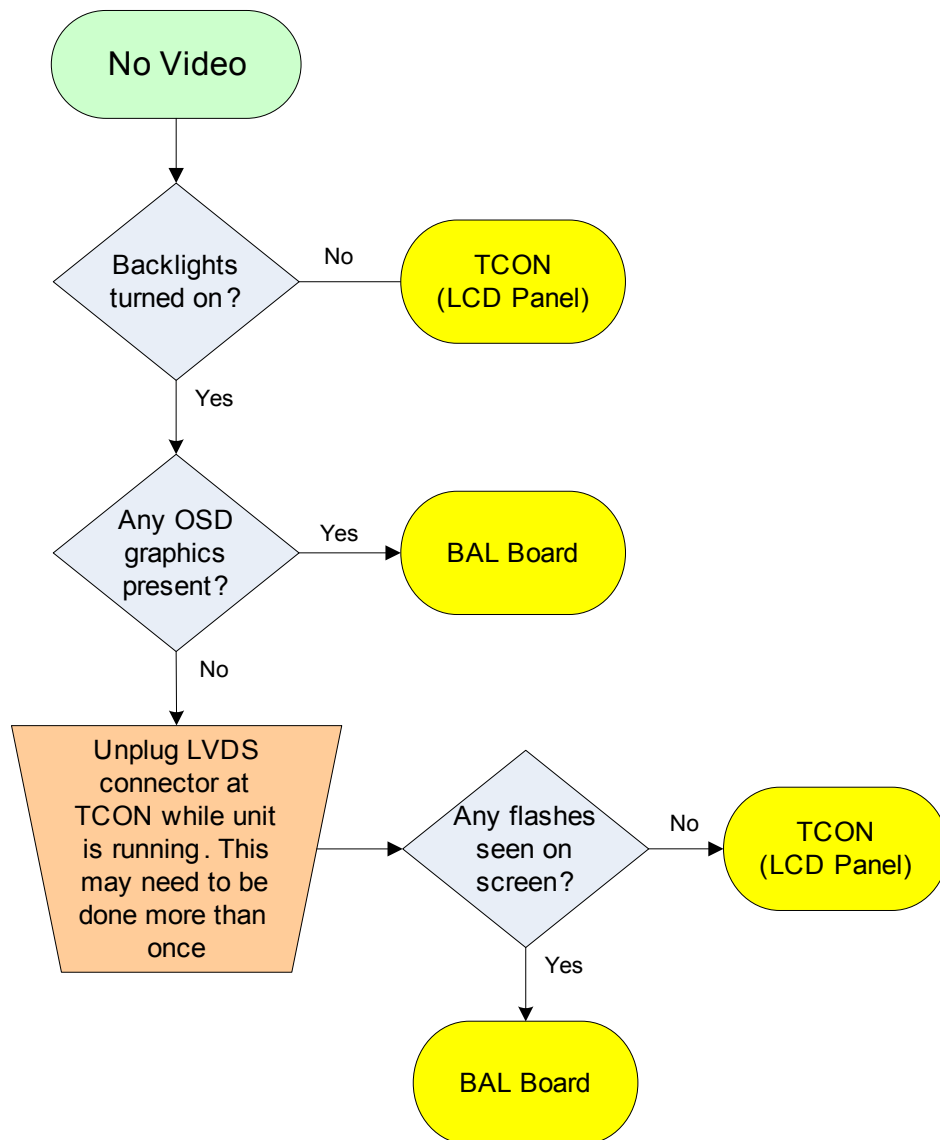
FIGURE 3-2  
NO VIDEO TROUBLESHOOTING FLOWCHART

The troubleshooting flowchart in Figure 3-2 should provide assistance in isolating the cause of the video loss.

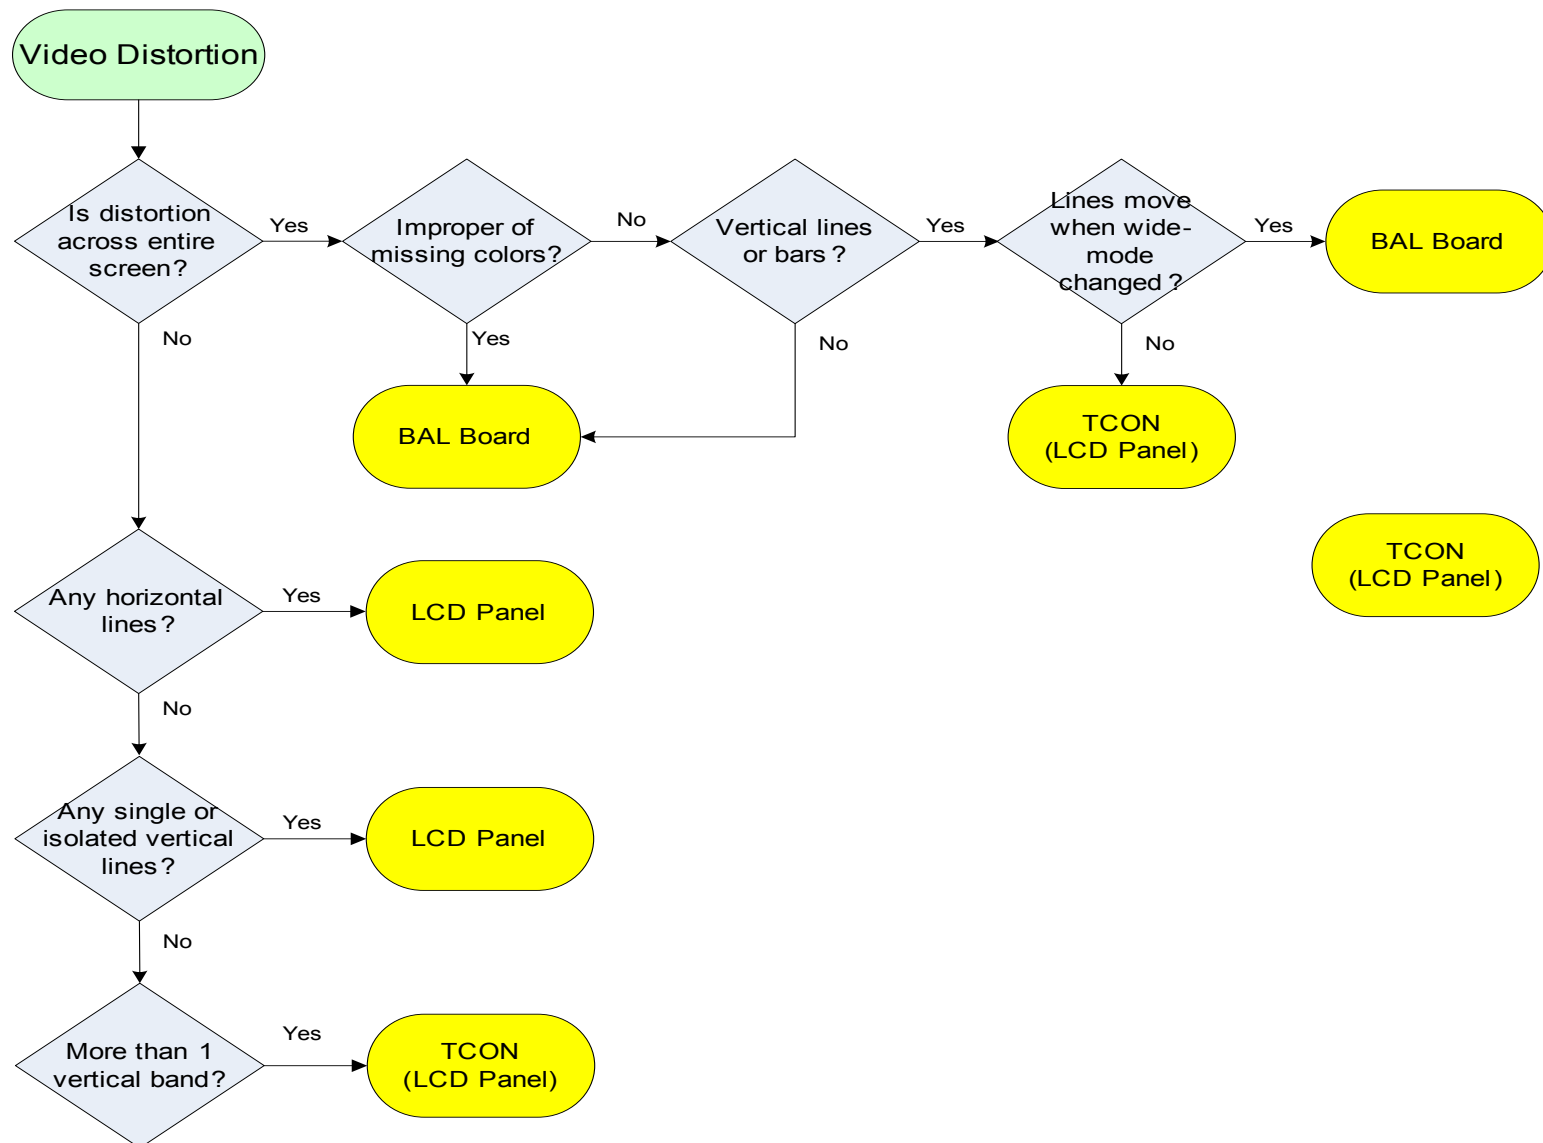
FIGURE 3-3  
VIDEO DISTORTION TROUBLESHOOTING FLOWCHART

The troubleshooting flowchart in Figure 3-3 will assist in isolating which component is causing the distortion.

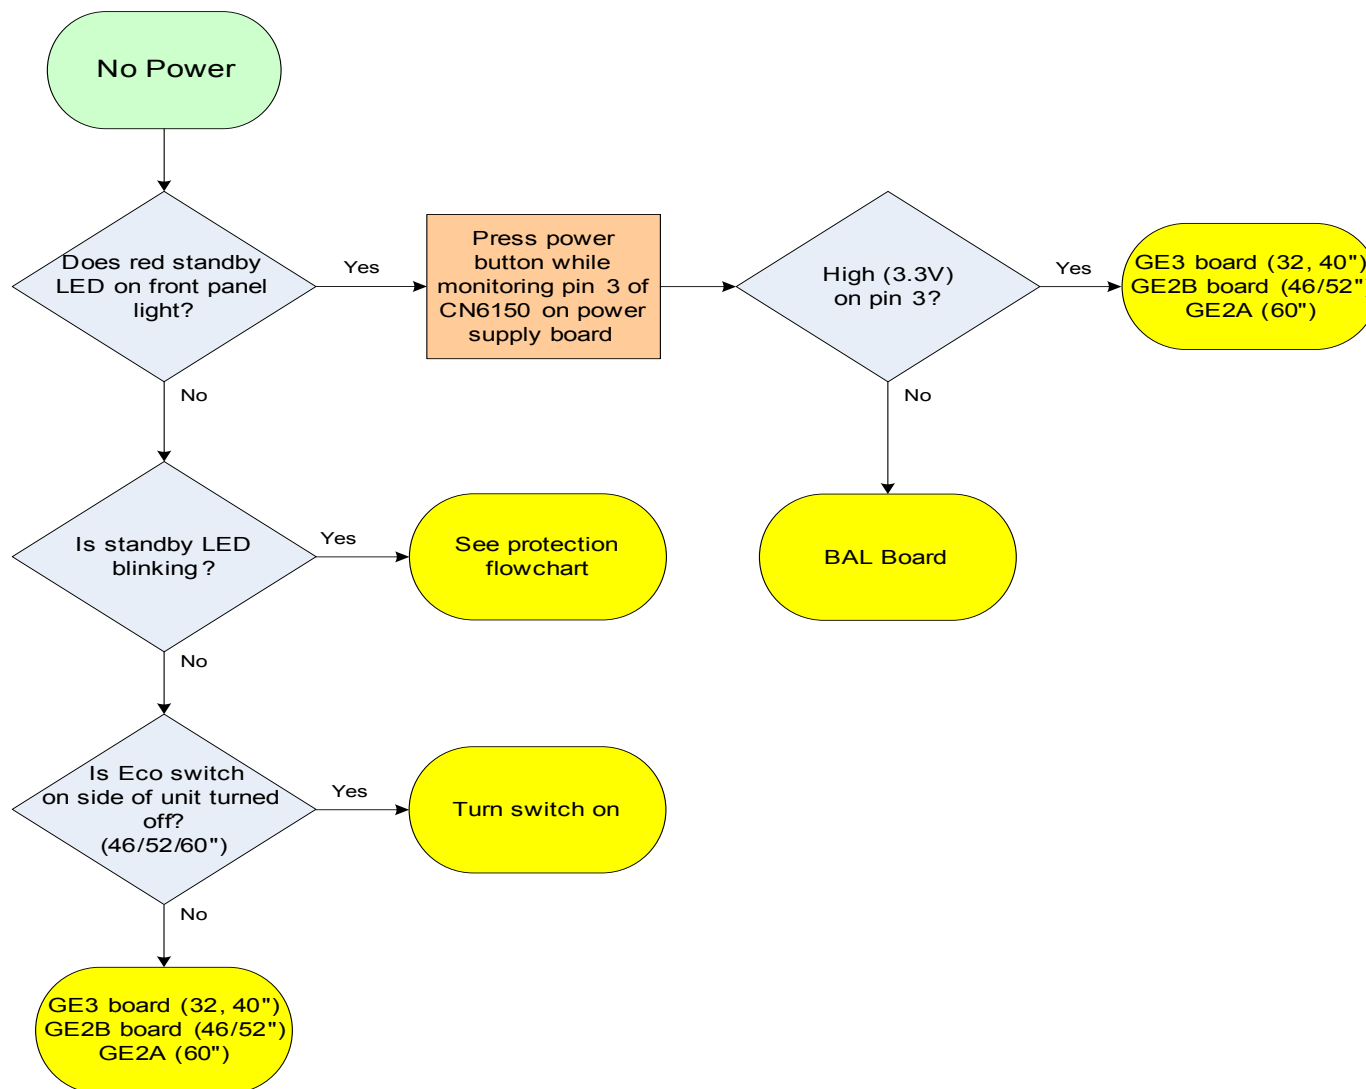
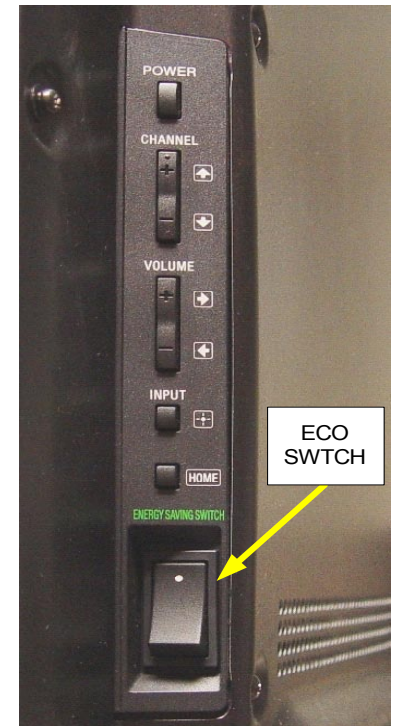
FIGURE 3-4  
NO POWER TROUBLESHOOTING FLOWCHART

**Service Tip:** If the standby LED is lit but the unit will not power on, remove AC power from the unit. This can be done by unplugging the AC cord or turning off the “eco” switch. Wait about 20 seconds and re-apply AC power. You should hear a distinct click of the main relay which will engage for about 5 minutes, 20 seconds before releasing again. If the relay clicks on, the power-on command line from the CPU is functional. Use the power-on button on the right side of the unit to attempt a turn-on and eliminate a defective remote control system. The troubleshooting flowchart in Figure 3-4 will assist in isolating the power problem.

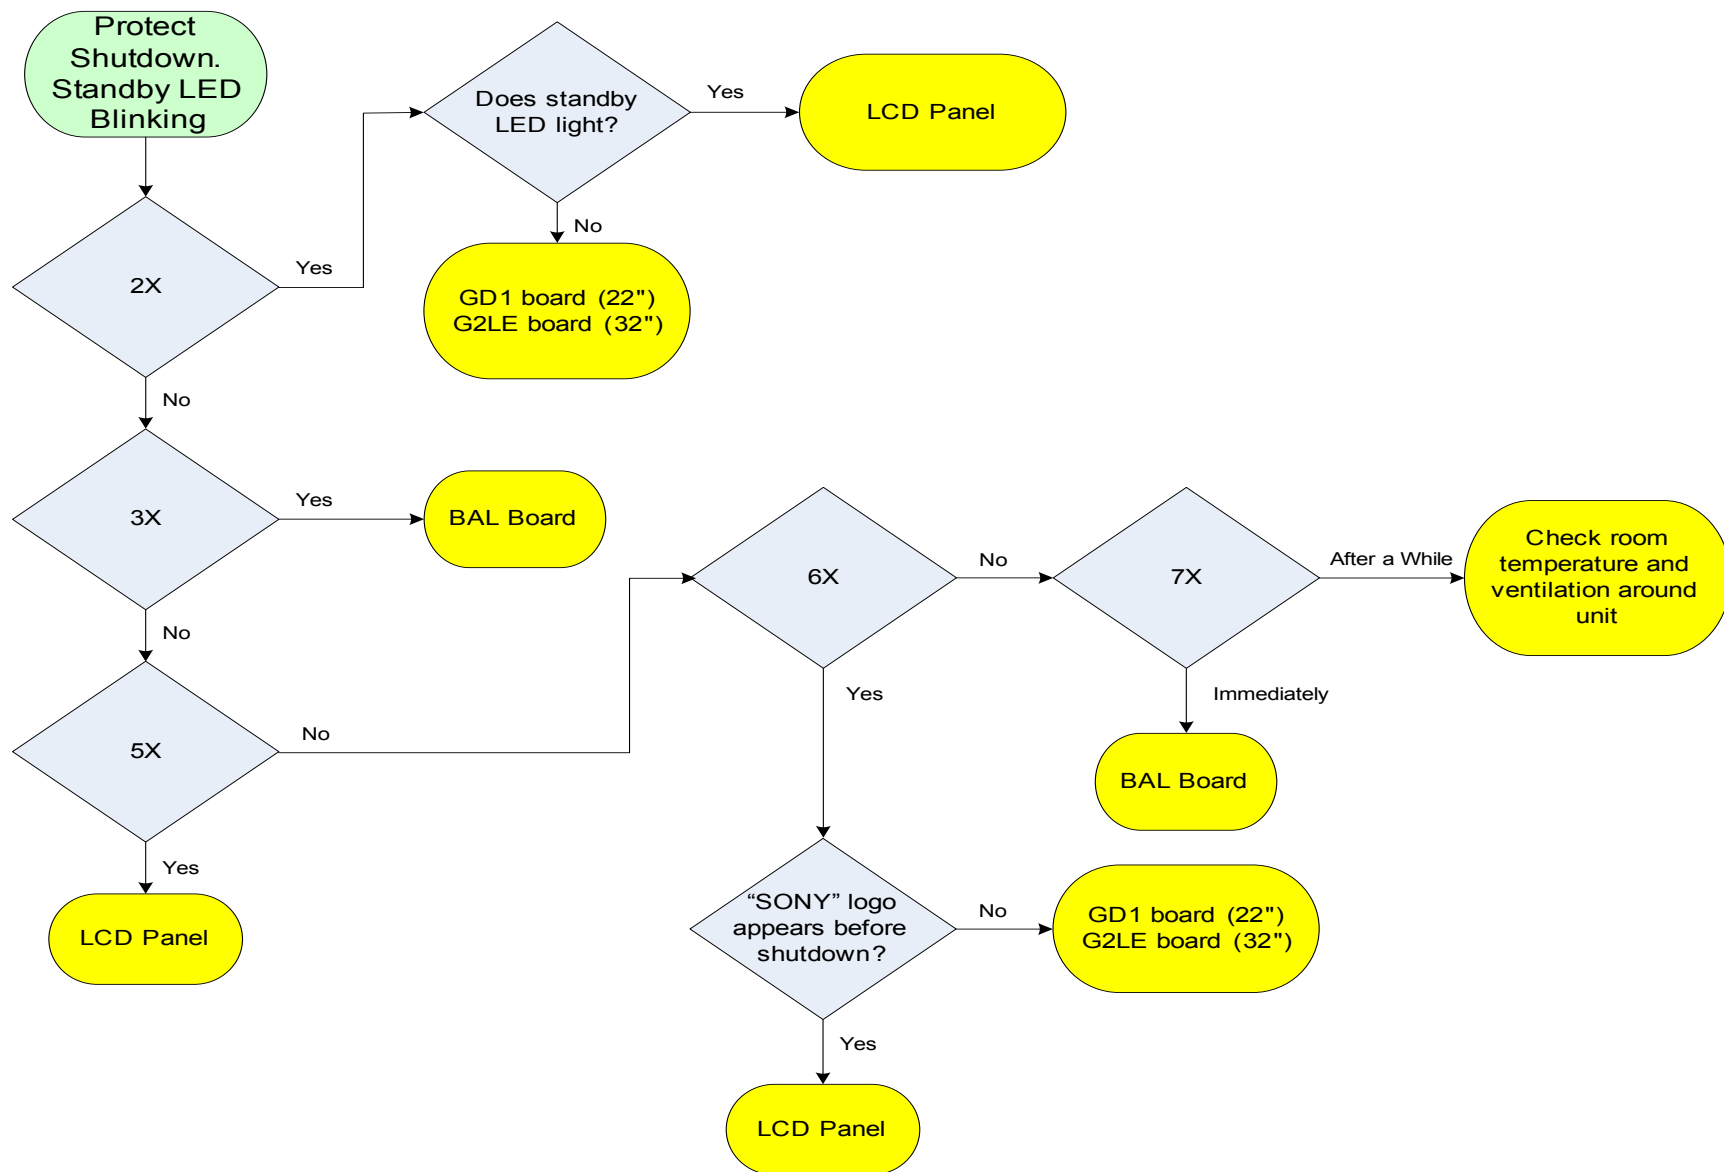
FIGURE 3-5  
PROTECT SHUTDOWN TROUBLESHOOTING FLOWCHART

Not all of the available protect codes are used. Models that are LED backlit do not use the 4-blink balancer error as this circuit is found in models that are backlit with fluorescent lamps. The following list contains the protect circuits and diagnostics codes used in the EX700 models. The troubleshooting flowchart in Figure 3-5 provides guidance in locating the possible component causing the shutdown.

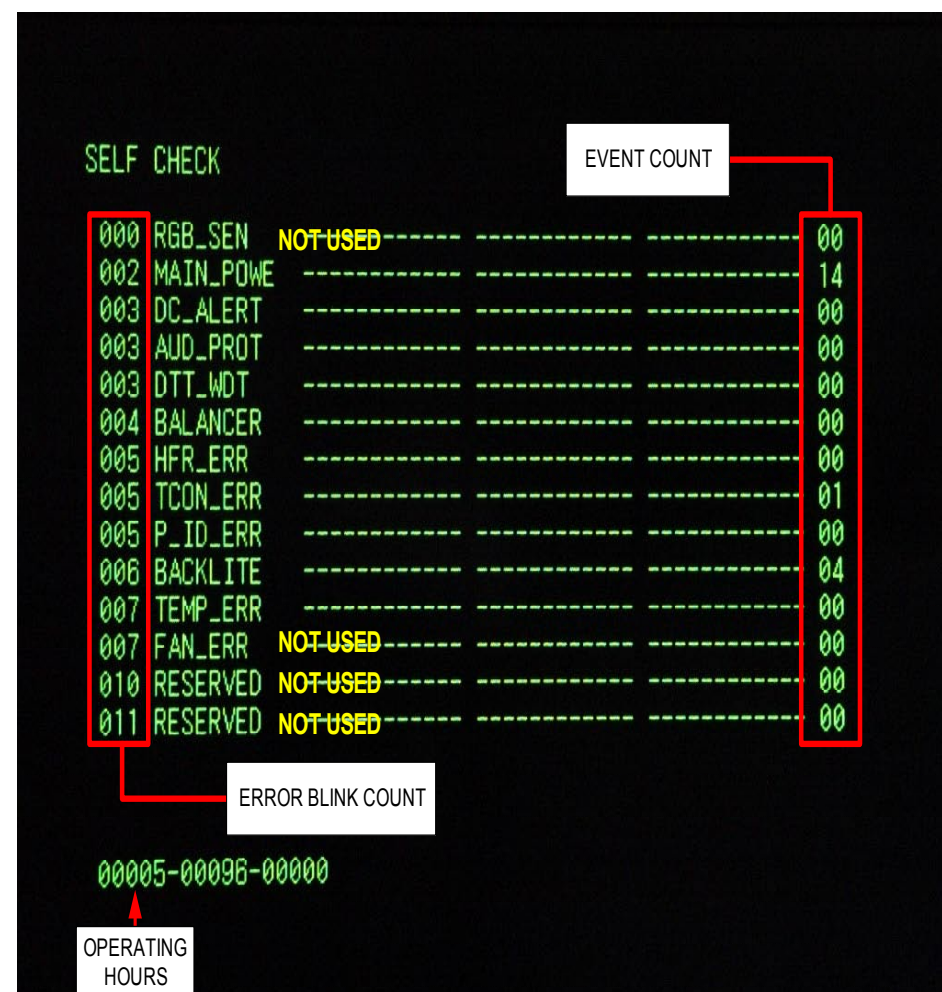
FIGURE 3-6  
DIAGNOSTICS HISTORY PAGE

Figure 3-6 illustrates an example of the diagnostics history page. Entry to this page is achieved while the television is powered down and pressing the following buttons on the remote commander: "DISPLAY", "5", "VOL -", "POWER".

This feature is useful for failures which are intermittent or when the customer is not sure what is causing the television to shut down sometimes. Once a corrective action is determined the error events should be cleared to zero. This is accomplished by pressing the "8" key followed by the "0" key on the remote commander.

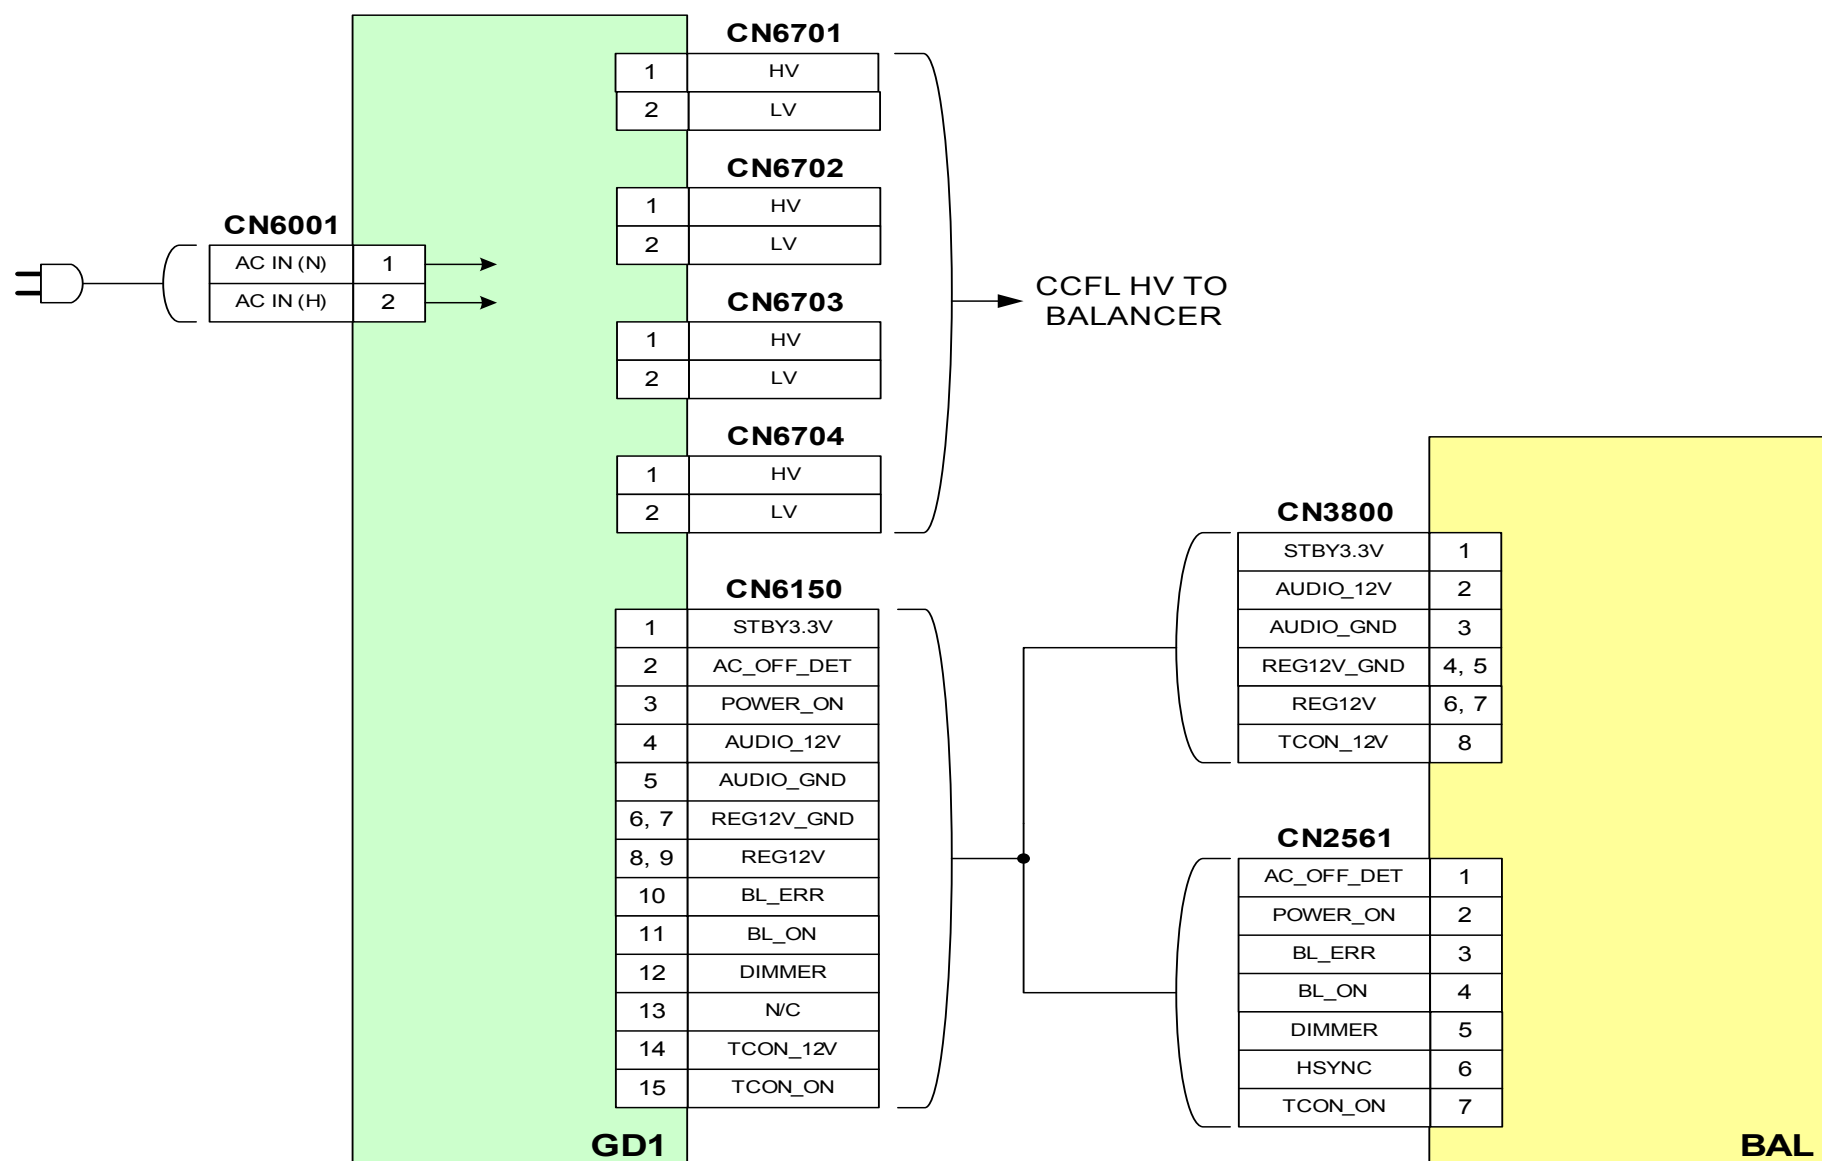
FIGURE 3-7  
KDL22EX308 TEST POINTS

The drawing in Figure 3-7 contains the board-to-board connector and pin information for the KDL22EX308 to identify voltages, signal and control lines for troubleshooting purposes. Figure 3-8 illustrates the same information for the KDL32EX308. All critical voltages and control signals are easily accessed at the power supply board. Use this drawing in conjunction with the previously discussed troubleshooting techniques and flowcharts for testing operating voltages and control signals.

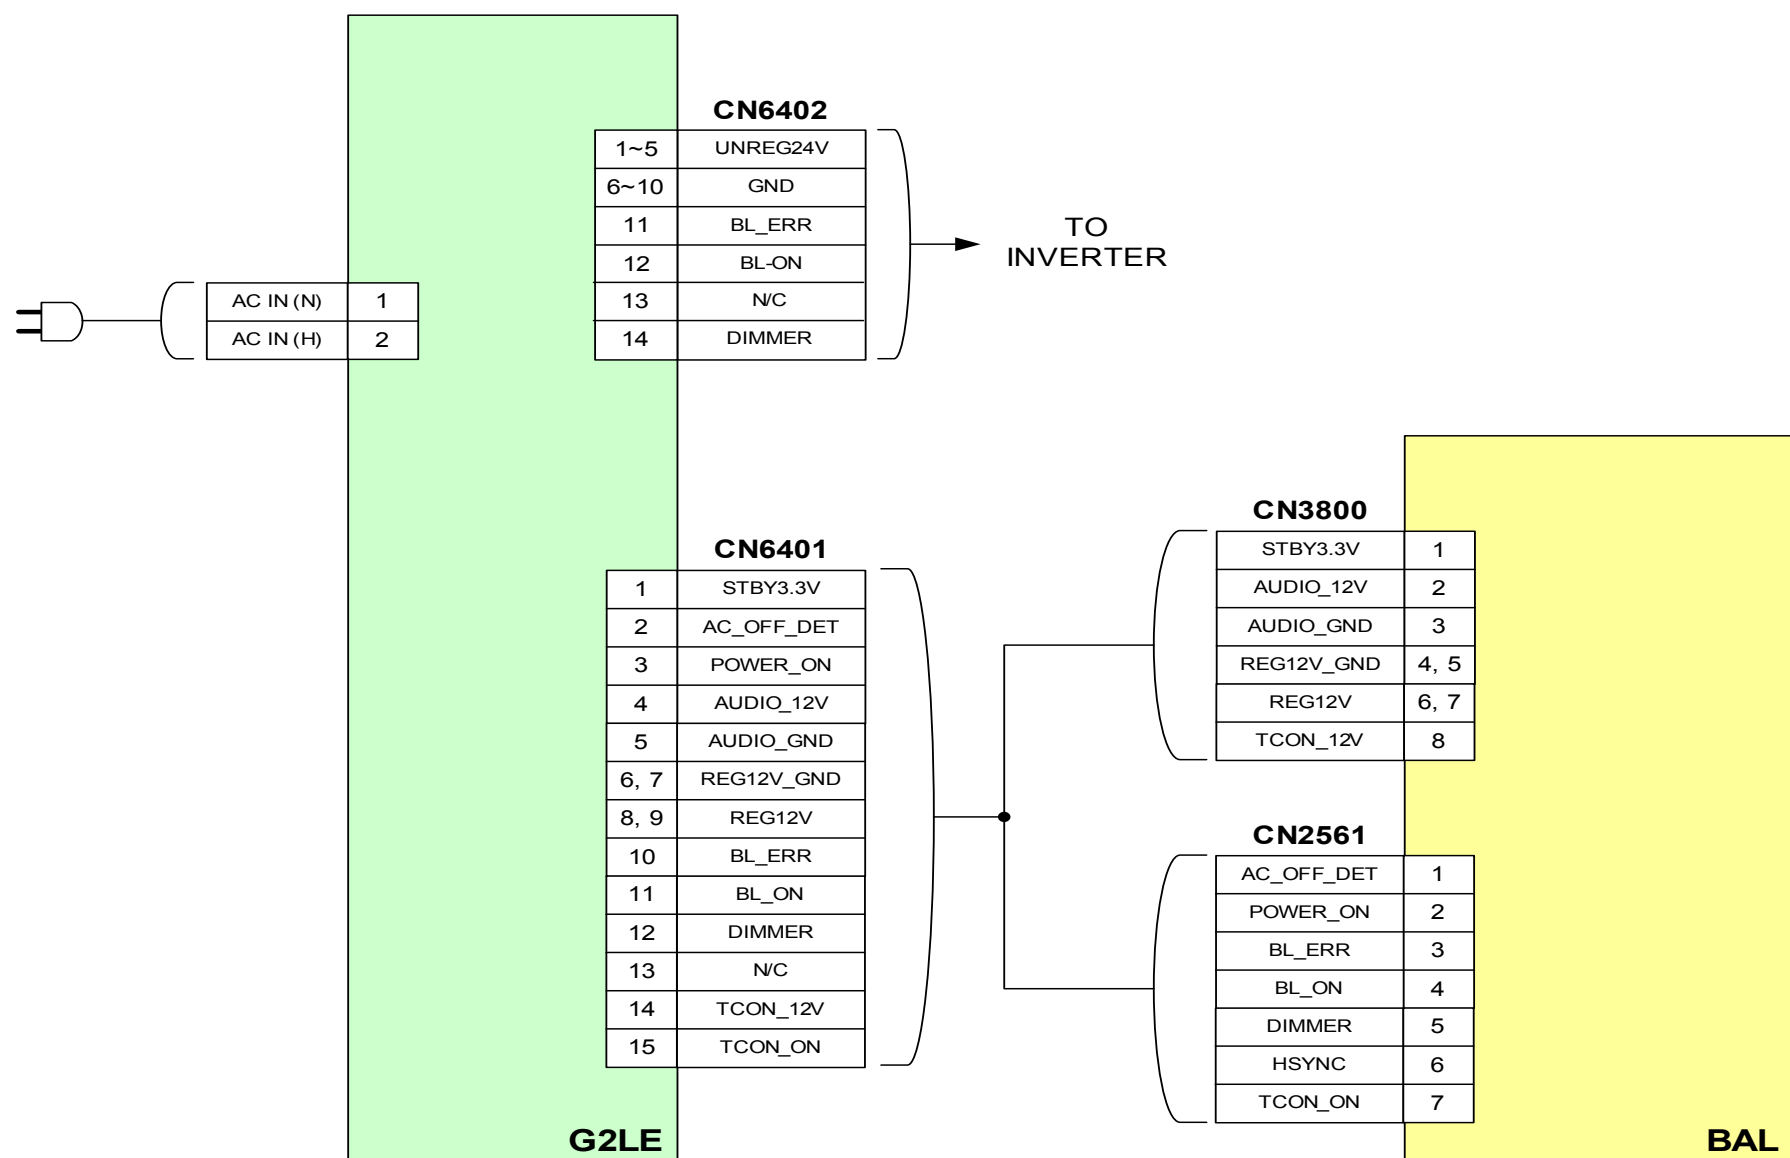
FIGURE 3-8  
KDL32EX308 TEST POINTS

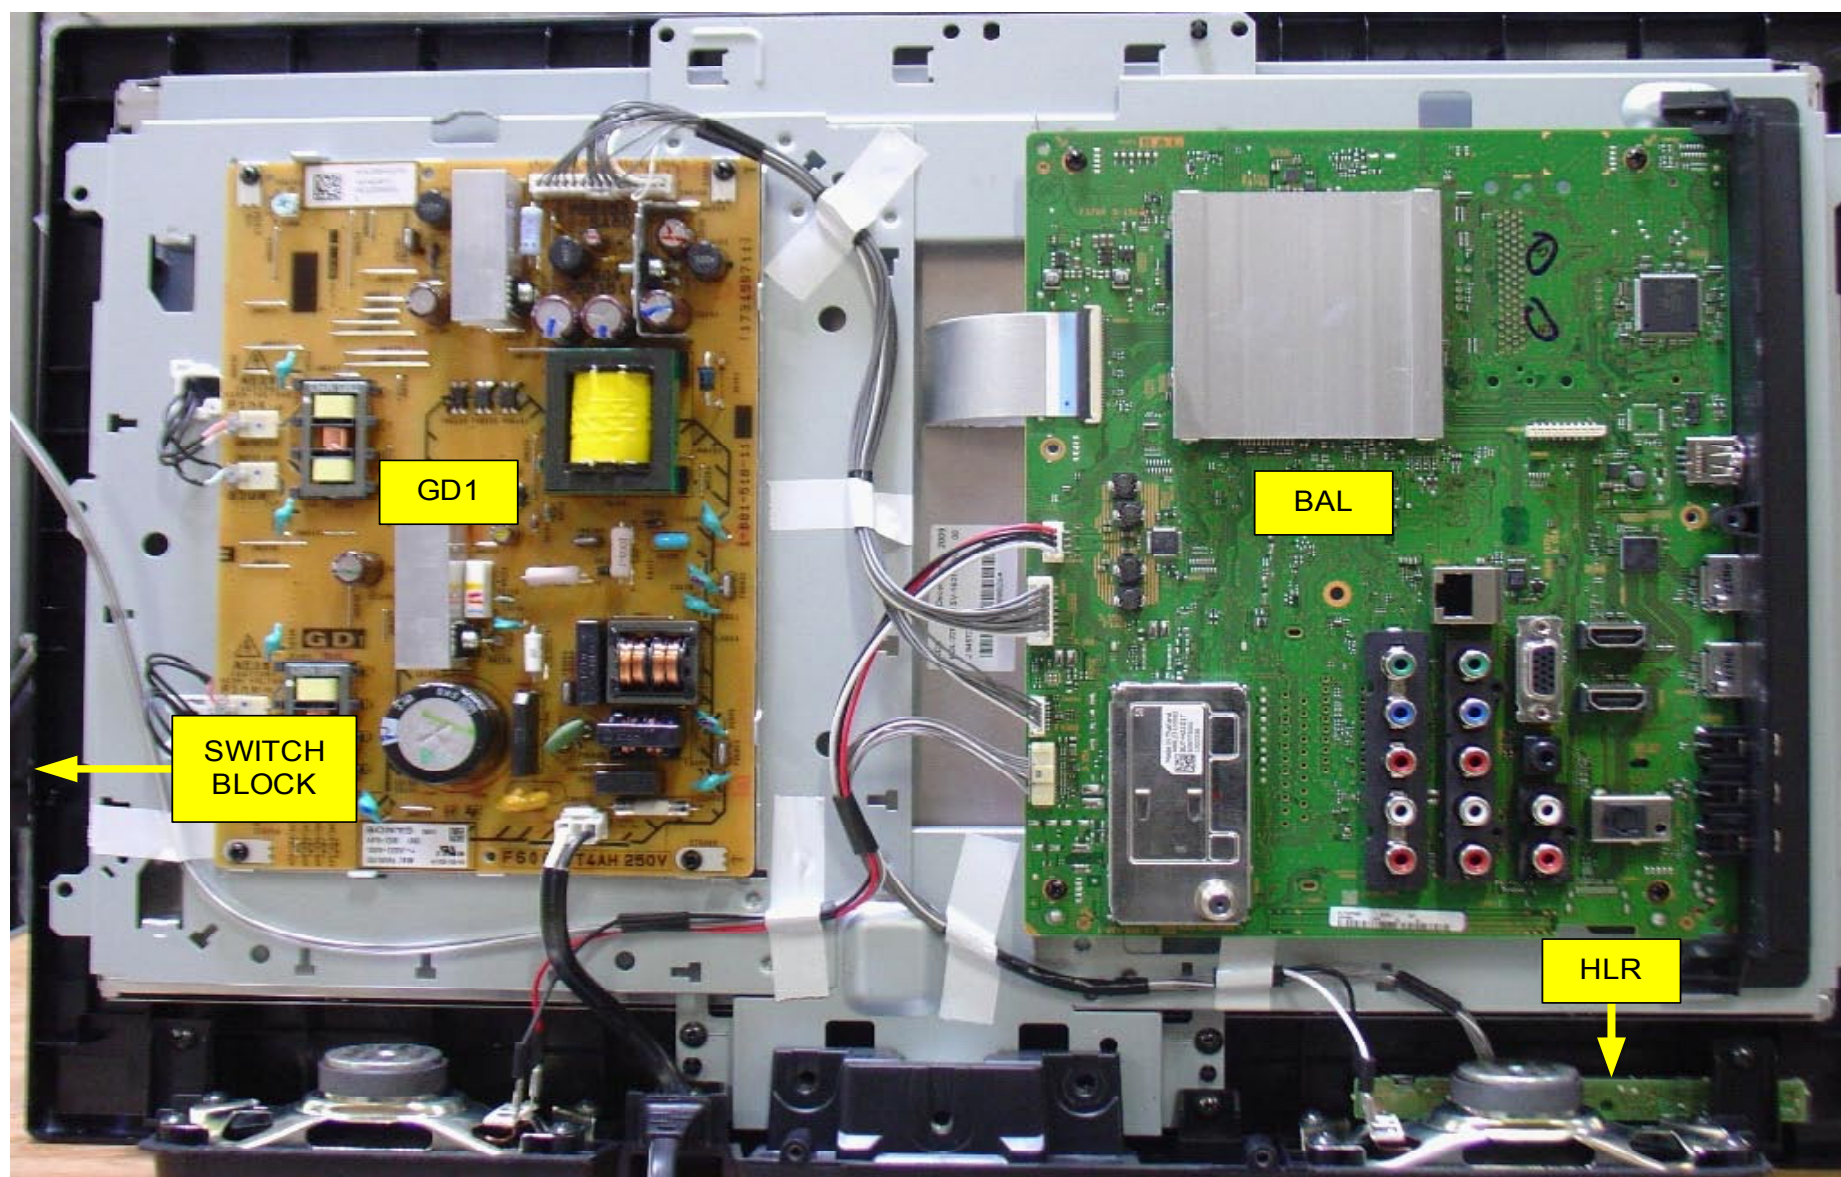
FIGURE 3-9  
KDL22EX308 BOARD LOCATIONS

Figure 3-9 illustrates the rear of a KDL22EX308 with the cover removed. The location of the major circuit boards and connectors for voltage checks is provided. An illustration of the KDL32EX308 is shown in Figure 3-10

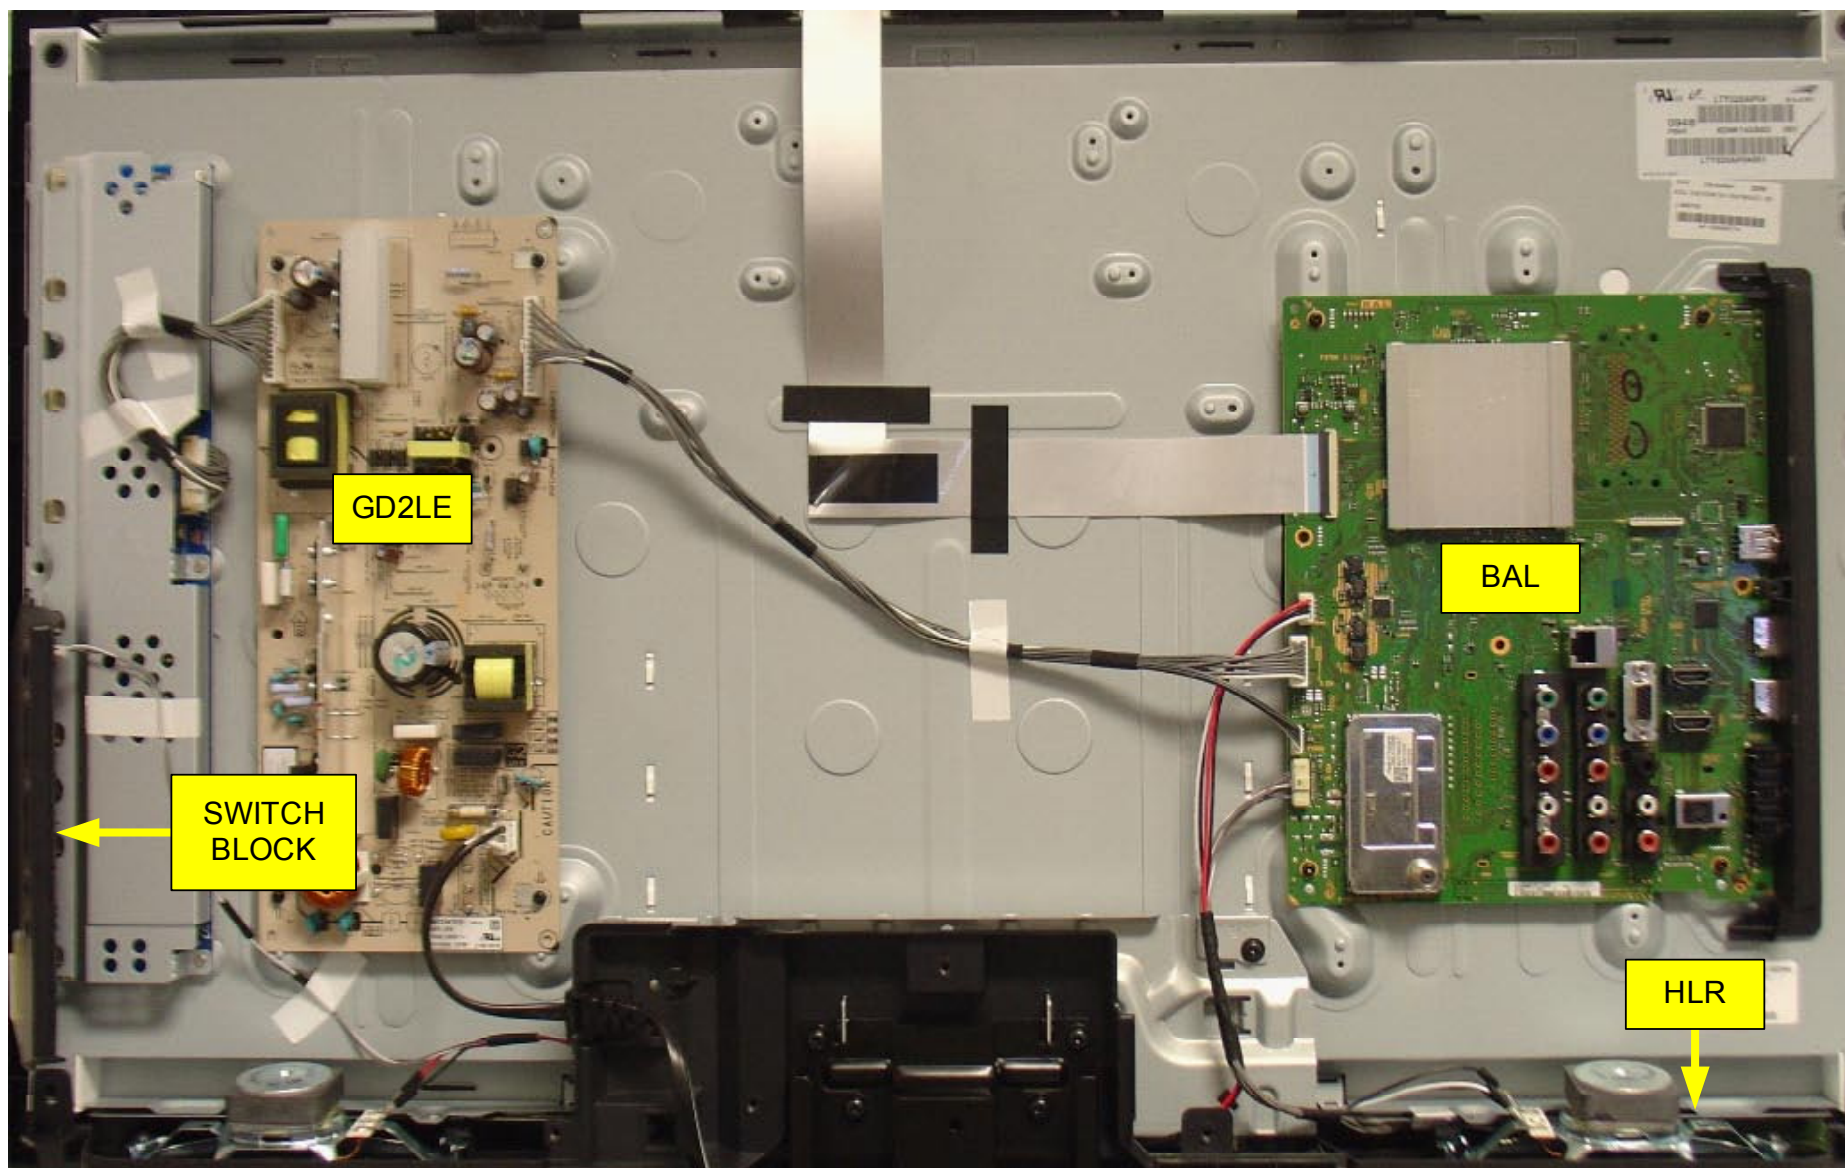
FIGURE 3-10  
KDL32BX300 BOARD LOCATIONS
